WATERWIDE

THE RISK ASSOCIATED WITH SPRAY IN COOLING WATER TOWERS

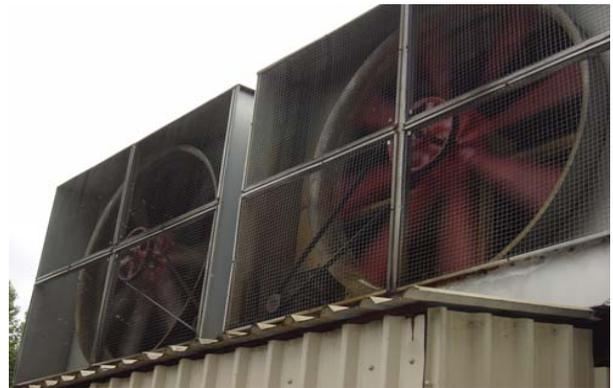
Many types of cooling water systems have the capability to produce atomised water and indeed many achieve cooling by way of atomising

water as a feature of the tower design.

Effective means of preventing this aerosol leaving the confines of the cooling tower are therefore essential if the Risk associated with the carrying of bacteria in the aerosol are to be minimised.

A typical cooling tower system has some form of drawing air over a cascading flow of water. Design therefore, has to allow unimpeded cool air in to the tower and warm, water vapour saturated air out of the tower, WITHOUT allowing the release of physi-

cal water droplets into the environment.

High efficiency drift eliminators are now commonly used in the head and/or sides of the tower. These are generally 'S' profiled moulded plastic strips which force the expelled air to turn abruptly causing the heavier water droplets to hit the 'S' bend and fall back into the system.

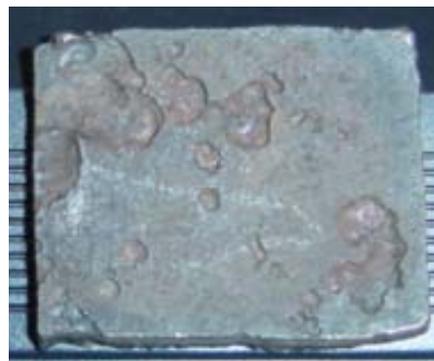
Pin Hole Corrosion as a result of anaerobic bacterial activity

As time passes, so the inner most areas of the biofilm can become devoid of oxygen resulting in anaerobic conditions being set up in the biofilm.

This has the result of killing off some of the bacteria which were involved in the initial formation of the biofilm, and also allowing new anaerobic tolerant bacteria to take over and develop. On particularly troublesome type of anaerobic bacteria are termed Sulphate Reducing Bacteria (SRB's) which, as the name suggests, utilise the reduction of the Sulphate molecule as a means of metabolism. This causes significant problems in localised areas through pin hole corrosion, a direct result of the action of active sulphide being produced as a by product of metabolism. This sulphide then reacts with water to produce a very corrosive liquor based on Hydrogen sulphide gas and/or Iron to produce Iron Sulphide.
